## Wooden Church from Târnăvița, Hunedoara County

Cristina Maria Dăneasă\*

**Abstract:** *Wooden Church from Târnăvița, Hunedoara County.* The wooden church from Târnăvița village is one of the most beautiful and valorous from Mureș Meadow, in Hunedoara County. This church from seventh decade of 17<sup>th</sup> century preserve the archaic forms and dimensions, with a interior paint from two periods – from 17<sup>th</sup> and 18<sup>th</sup> centuries. Is a listed monument in A class, but its state of conservation is poor. This monument is representative for wooden churches from Mureș Valley in Hunedoara County and its integral saving must to be a priority for the specialized teams.

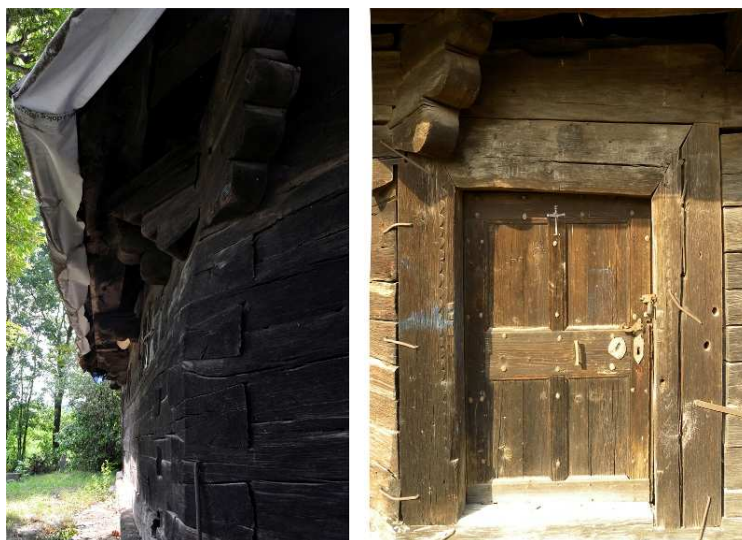
beams are horizontally placed, all in all, and dovetail jointed. Transversal walls are jointed with north and south walls with half joints. The massive frame of the door, jointed with bridle joints, maintain the old hols of wood latch. Bulging beams from the top of the walls are decorated with big carved retreated lobes. On this consoles rest the ground beam, at distance from walls, with special places for the spars. All sills and walls are consolidated with metallic nails and cramps (Fig. 1 a).

Fig. 1 – a. Dovetail joints and decoration of consoles; b. The door from north side of narthex.

narthex, and the altar has three entrances, but Ioana Cristache Panait submit the possibility of existence of two entrances. We consider that in the moment of the first paint site from 17<sup>th</sup> century was already three entrances (after analyzing the outline and decorative motives from these areas) (Fig.1 b).

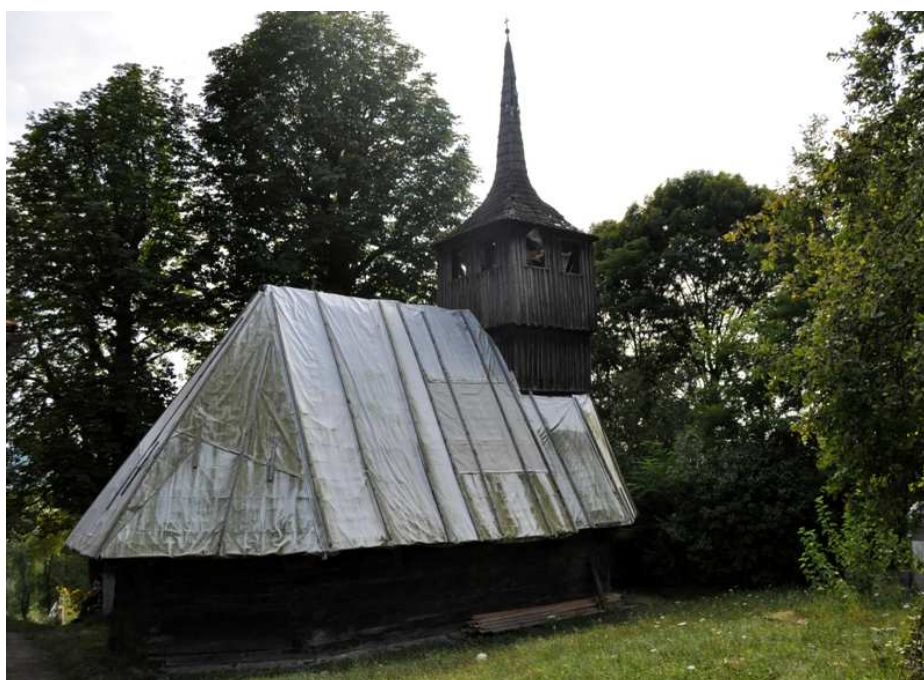
Fig. 2 – Wooden church from Târnăvița village, north-east view

The roof, unique for all construction, copying the plan is covered with two layers of hand-made shingles. To protect the church with damaged roof, in august 2009 was covered with a temporary protected canvas. The robust bell tower has a rectangular plan, is posted upper narthex, and has a pavilion on sills and two windows on each side of the gallery. Bell tower roof has a double pitch and is covered with shingles (Fig. 2).

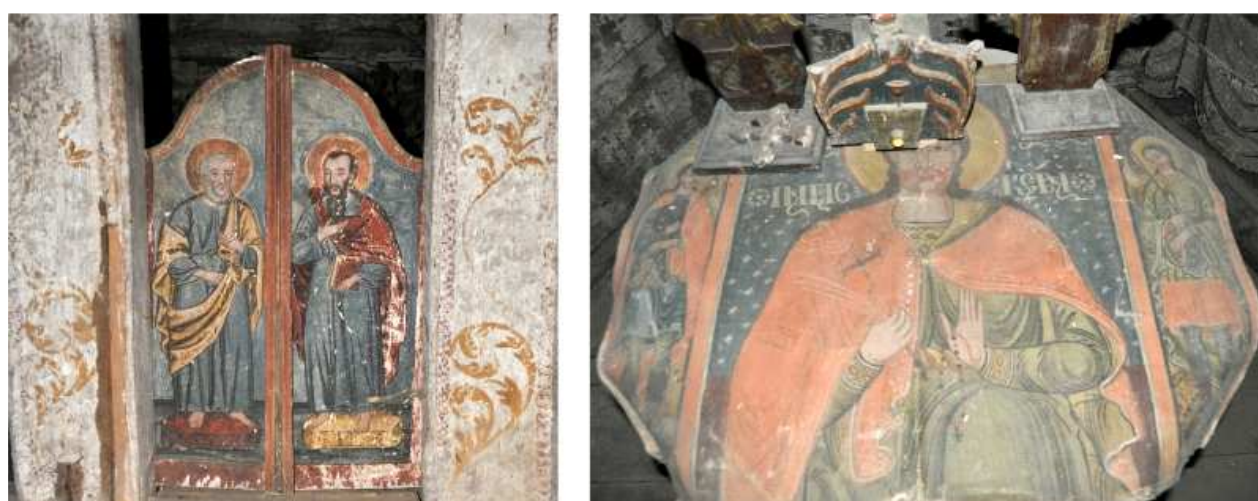
Fig. 3 – a. Imperial doors; b. The ceremonial Flag from altar table

and apostles on the iconostasis. In nave, on the north and south walls are painted saints, but the paint is lost in major part. On the imperial doors are painted Petru and Pavel Apostles (Fig. 3 a). In altar are represented scenes, saints (hierarchs and archdeacons Aavram Sacrifice, God Father, Virgin Mary with Jesus in her arms, etc) (Dionisie din Furna, 2000) (Fig. 4).

Inside are still preserved two icon supports, painted with vegetal and geometric motifs. The altar table, made from stone, is covered with an old ceremonial flag, which is painted on both sides with oil colours, representing Three-in-one in occidental style on first side, and Saint Parascheva with Mihail and Gavril Archangels on second side (from 19<sup>th</sup> century) (Fig. 3 b). On

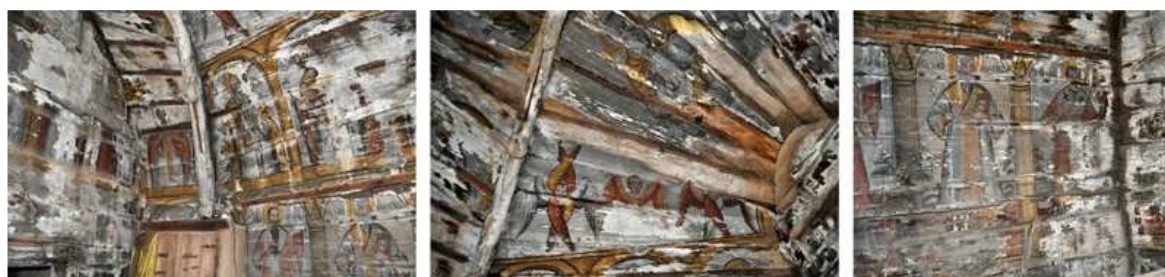
Fig. 4 – Interior paint from altar

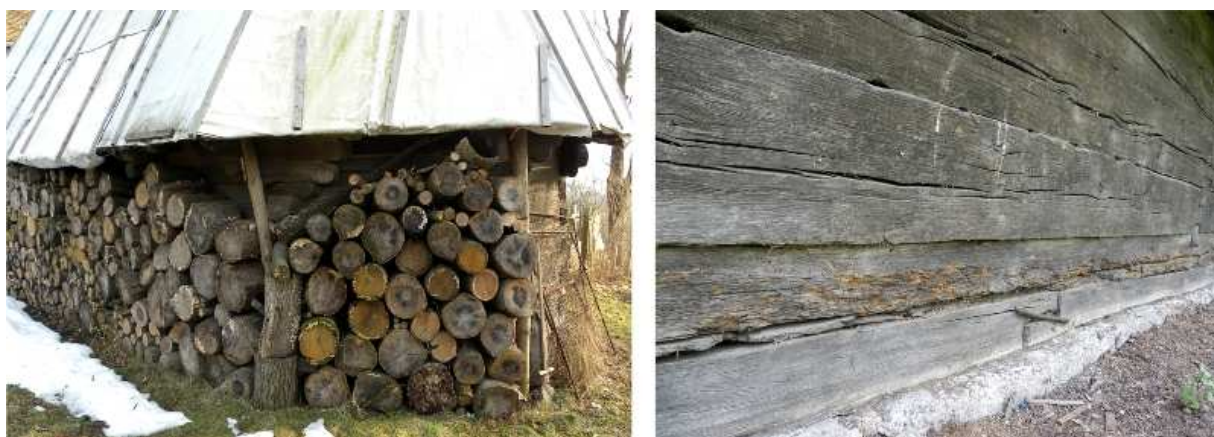
Fig. 5 – a. Wooden pieces stored on the walls; b. Biological attack at the beams

The church has the main disadvantage its position near trees, the new church and the hill slope is in north-south direction. The basement is consolidated with concrete, in not enough high and the sills reach at ground level. Between basement and sills is a isolation with asphalt board, which at on the north part is not efficient. We can observe the effect – biological attack is much more intense, on big areas at sills and walls. These degradations were accentuated because the high humidity was maintained by the pieces of wood stored during cold season, on the north, north-east and north-west walls of the church (Fig. 5 a, b).

Humidity average of the wood was registered from the sills and walls. The major values were at sills to the all sides (*aprox.* 16, 17%), at walls the averages to the all sides were from 14 to 16% in the median areas and in the upper part the average was 15-17%. From here we can observe that the high humidity favour biological attack of insects and fungi.

Other emergency measures are: rebuilding and exalting the basement, improving drains, treatments and consolidation of sills, walls and floor, obstructing the blanks with grates to prevent birds and animals to enter. Structures of roof and bell tower have to be consolidated. The monument has to be anti fire and anti effraction protected, using special alarms and fire extinguisher (with water mist for interior paint) manually and automatically. For permanent monitoring of interior microclimate (temperature and humidity) is recommended to install data loggere. Nearby trees is recommended to be felled, all vegetation and cleanness to be maintained. Is indicated the scientific restoration of interior paint in the shortest time.

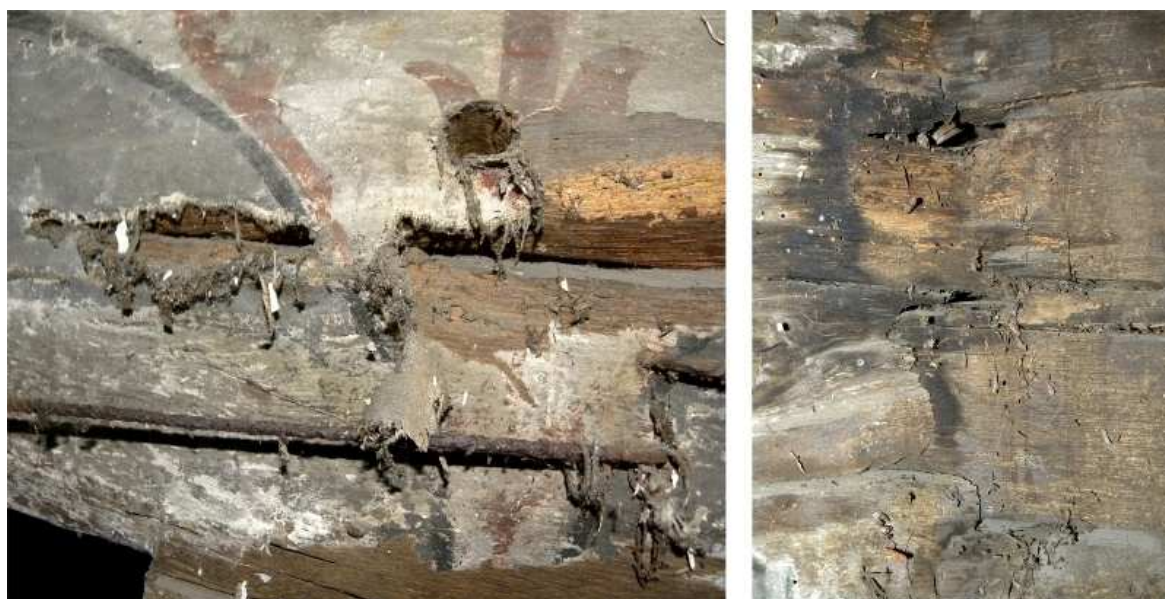
Fig. 6 – a. degradation of interstitial canvas; b. Degradation of beams – inside the church

Regarding interior paint we observe that in a major part the painting layers was washed by water from infiltrations (the most exposed areas are: in narthex, on the walls, in nave on the walls, median, north and inferior part of arch, in altar on the central and south part at the arch, north-east, south and upper part of walls), and interstitial canvases are fallen, decayed, lost and rotten. On all paint layers are moisture marks and stains (Fig. 6 a, b).

out in the shortest time remember: prophylactic consolidation of interior paint, changing the old shingles with another one, handmade, moving pasted wall furniture, of ceremonial flags and icon from iconostasis that cover the original paint.
